QSET – Preliminary Incident Alert

Alert No: 145

Date: 04/08/16

Failure of EWP Jib Ram Pin

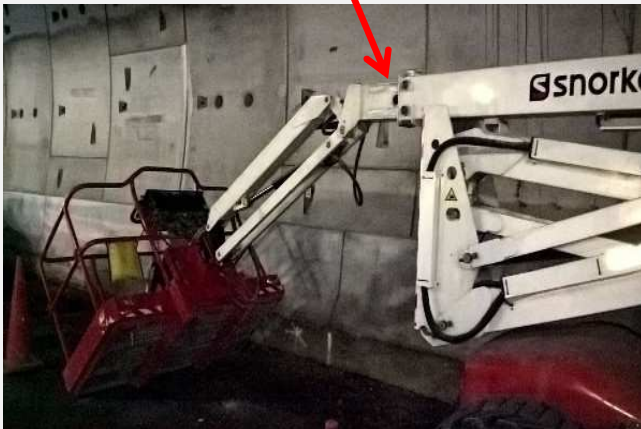
A worker fitted his harness and attached his lanyard to the anchor point then began to raise the EWP basket when the basket uncontrollably tilted forward striking the ground. The basket was 2.5 m off the ground at the time of the failure; he remained in the basket and has escaped with a minor bruising to his hand and hip. The unit is a Snorkel EWP A46JRT. The project has inspected the other Snorkel A46JRT unit that is on site and found the same component to have significant wear.

The jib ram stepped pin locking bolts (29) broke due to shear/rotation force and both of the stepped pins (24) subsequently came out. The mounting area for this is inside the main boom and is hidden/captured until it is extended. Once the stepped pins came out, picture above, it had only one pivot point and allowed the basket to fall with gravity like in this instance.

- Stood all Snorkel EWP's down and conducted an inspection of the jib ram pins
- Inspect a cross section of other brand and type EWP unit's ram pins for damage
- Contacted manufacturer (Snorkel) and maintainer of unit to commence joint mechanical investigation of failure
