Reference: 15-02

25 February 2015

REPORT OF SURVEY – HUNUA FALLS

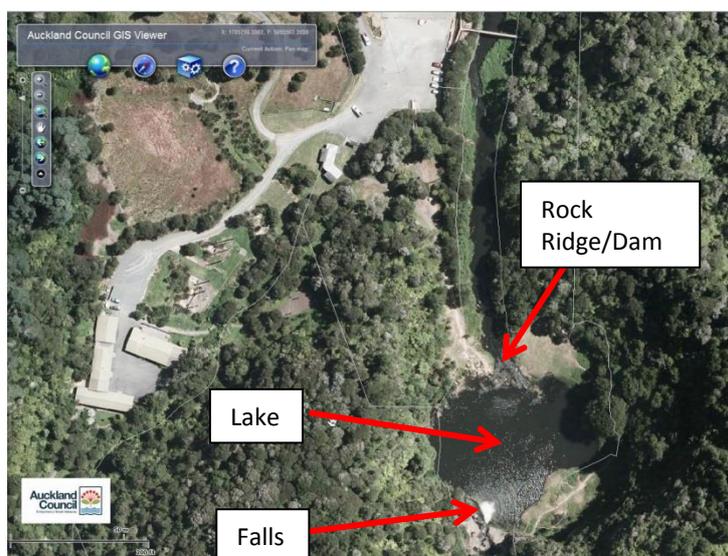
Auckland Council contracted Discovery Marine Ltd (DML) to undertake a survey of the lake and the surrounding low lying flat land at the base of the Hunua Falls in accordance with the DML proposal of 9 December 2014. The falls are a popular swimming and recreation location in the Hunua Regional Park. The general location of the lake and falls are indicated in the following image.

The lake is approximately 60m across and is formed behind a rock ridge that dams the discharge into a small stream. The deepest part of the lake is approximately 17m lower than the level of the rock ridge.

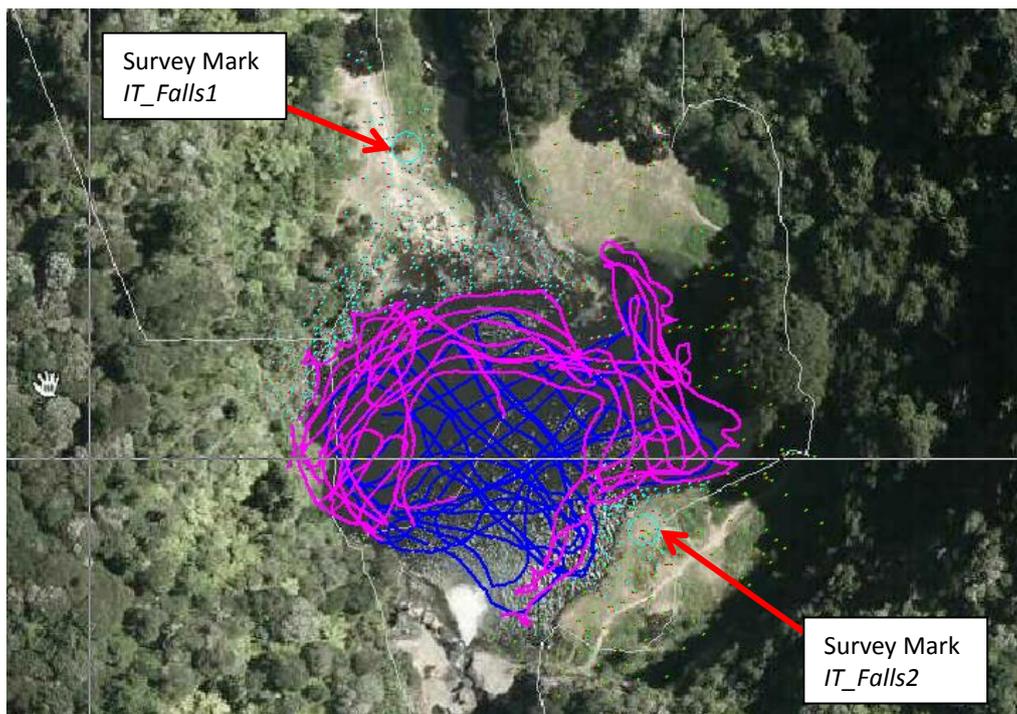
The following image shows the survey coverage achieved. The single points shown are spot positions from RTK and Theodolite/Prism observations, whereas the pink track lines are from the Kayak work (shallow) and the blue track lines from the inflatable dinghy (deeper areas).

This survey was conducted in two separate phases, the first on 27-28 January 2015 involved static GPS observations of up to four hours each at three locations. These observations were used to compute the position of marks to be used for this and any future surveys. Observations were made at: a known existing LINZ mark (LINZ Code A8TU) and two iron tubes installed by DML adjacent to the falls area. (Marks IT_Falls1 and IT_Falls2, see above image for approximate location).

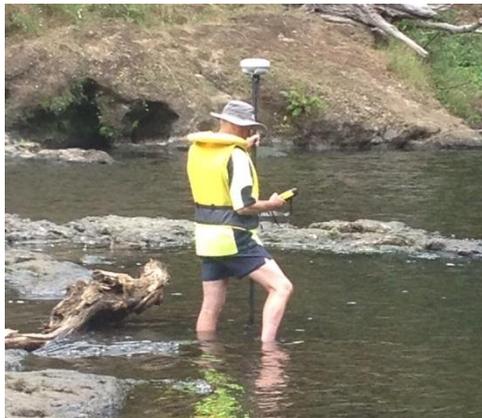
RTK Topographic Surveying across the rock ridge and shallows

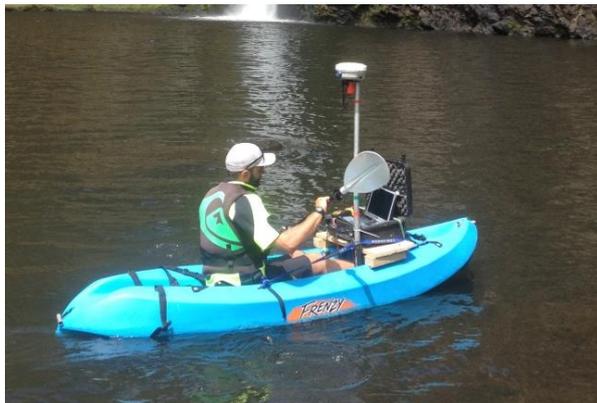
Surveying by Kayak

This hydrographic survey was undertaken using DML's kayak and 3.0m inflatable boat as shown below. Both were fitted with the equipment described below.

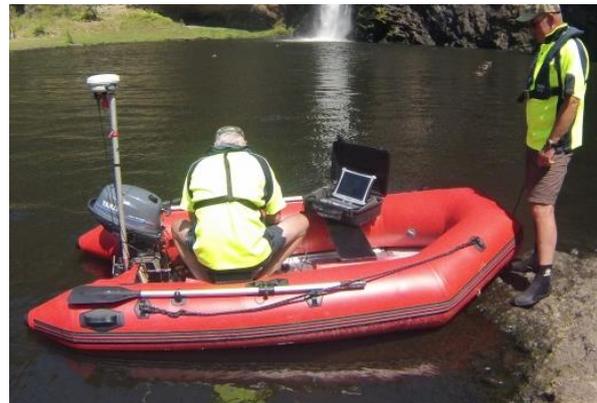
Surveying by Inflatable Dinghy

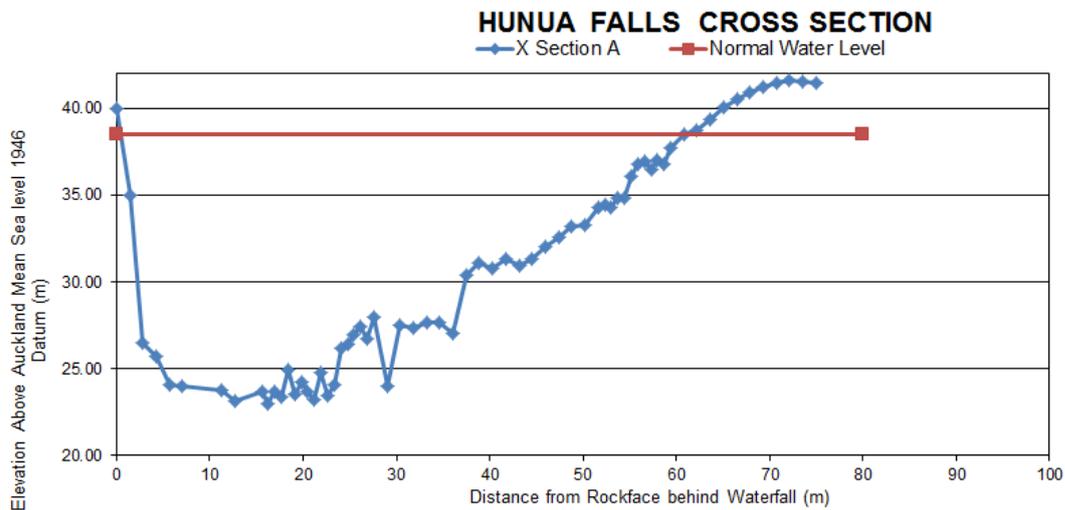
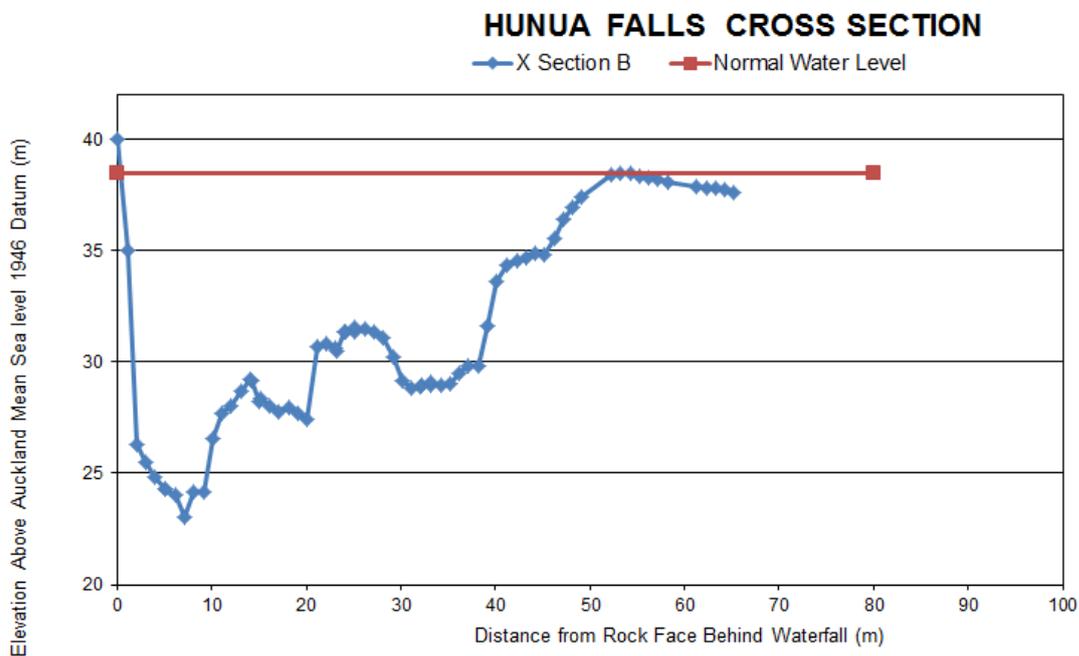
The 2D image and the two cross sections were generated from data gridded at 1m intervals. Elevations on the 2D image are referred to Auckland MSL 1946 vertical datum.

The greatest elevation difference obtained between the high point on the rock ridge (38.5m) and deepest part of the lake was 17.1m. The deepest part is approximately 2m off cross section A on the western side, at a distance of 12m out from the rock wall behind the waterfall.

The gridded data points behind the waterfall were edited to reflect both the steepness of the cliff behind the waterfall and to ensure depth contours reflected the seabed shape. The XYZ data for the two profiles is included in the excel sheets provided.
